**Bridger Range, Ramp**  
**Bridger Range**  
**MT**  
 Elevation: **8000 ft**  
 Aspect: **NE**  
 Specifics: **Ski tracks on slope; We skied slope**

**Spencer Jonas**  
**Sat Nov 11 14:45 2017**  
 Co-ord: **45.82853N, -110.93153W**  
 Slope Angle:  
 Wind Loading:

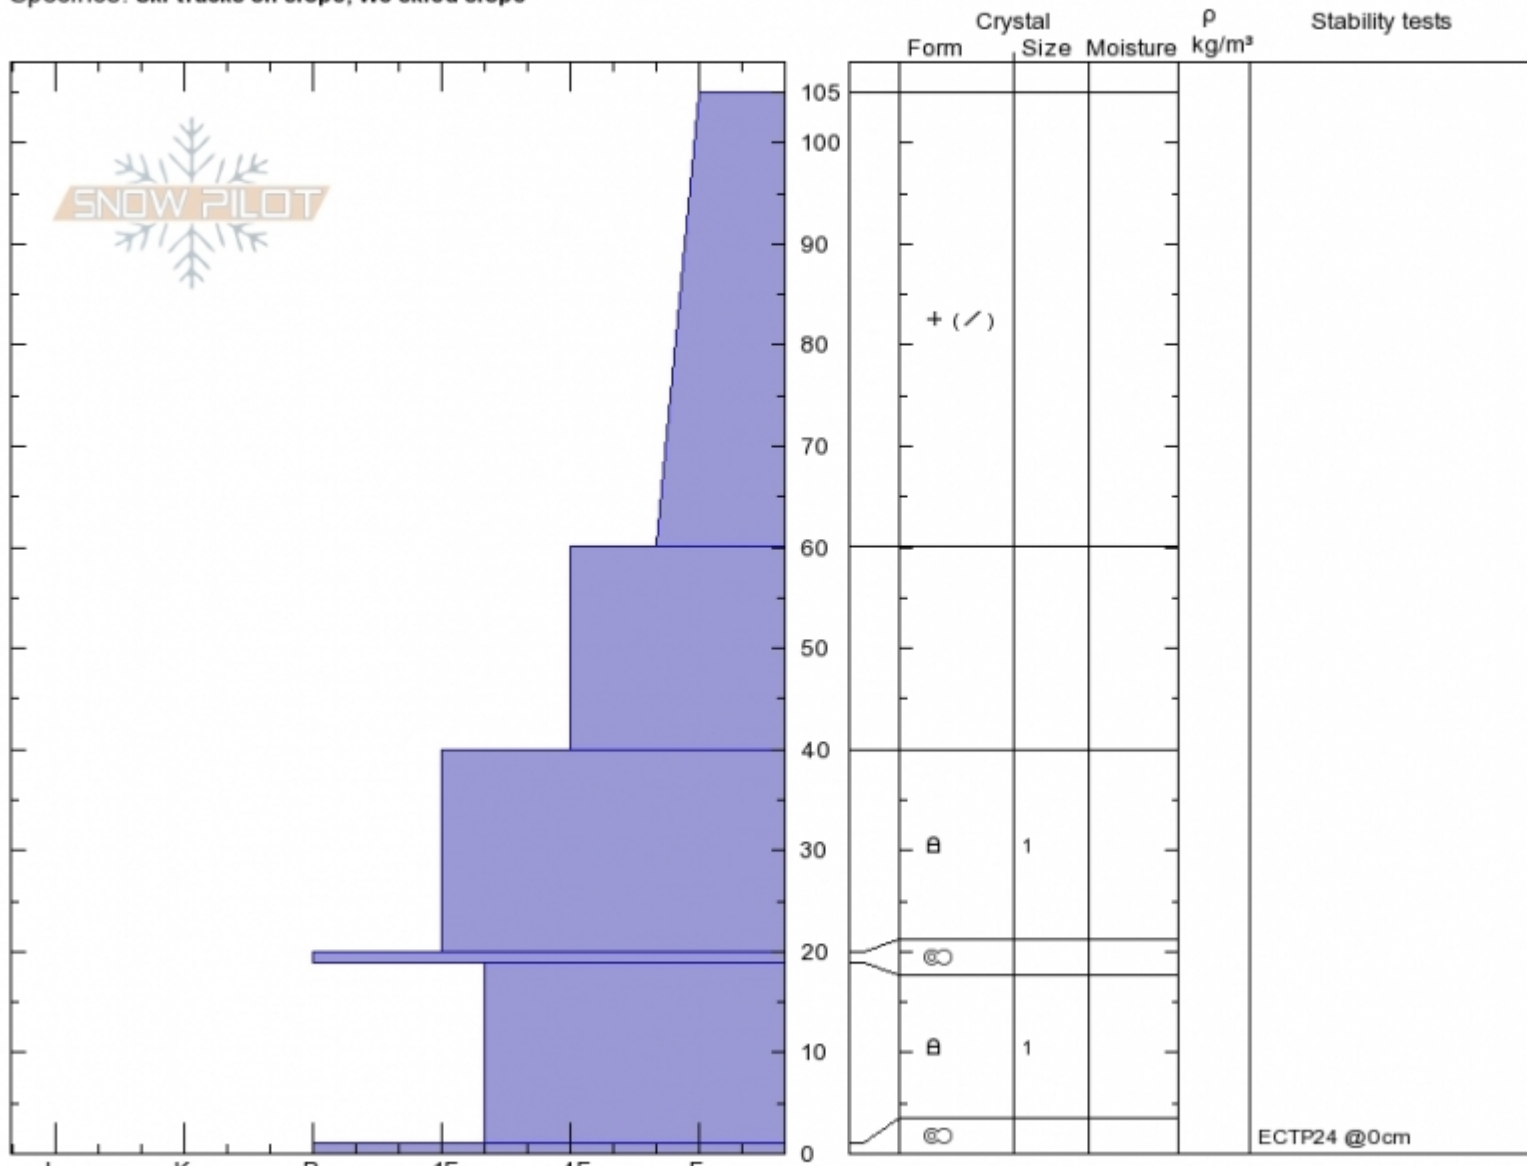
Notes: There was an air pocket between the ice crust that formed the bottom layer and the ground. The column failed when the ice broke a little ground that it was attached to, a small root and rock at the back of the column. Our layer of concern was the old September snow. There was no sign of instability at its interface. It is hard to interpret the ectp as a sign of instability, it seemed to be more an issue of ground movement specifically beneath the column and not an indicator of overall instability at the ground.
