Advisory Region Bridger Range Longitude -110.94W Latitude 45.79N **Avalanche Details:** <u>Natural Avalanches on Saddle Peak</u> **Forecast link:** <u>GNFAC Avalanche Forecast for Wed Nov 27, 2024</u> Bridger Range, 2024-11-25

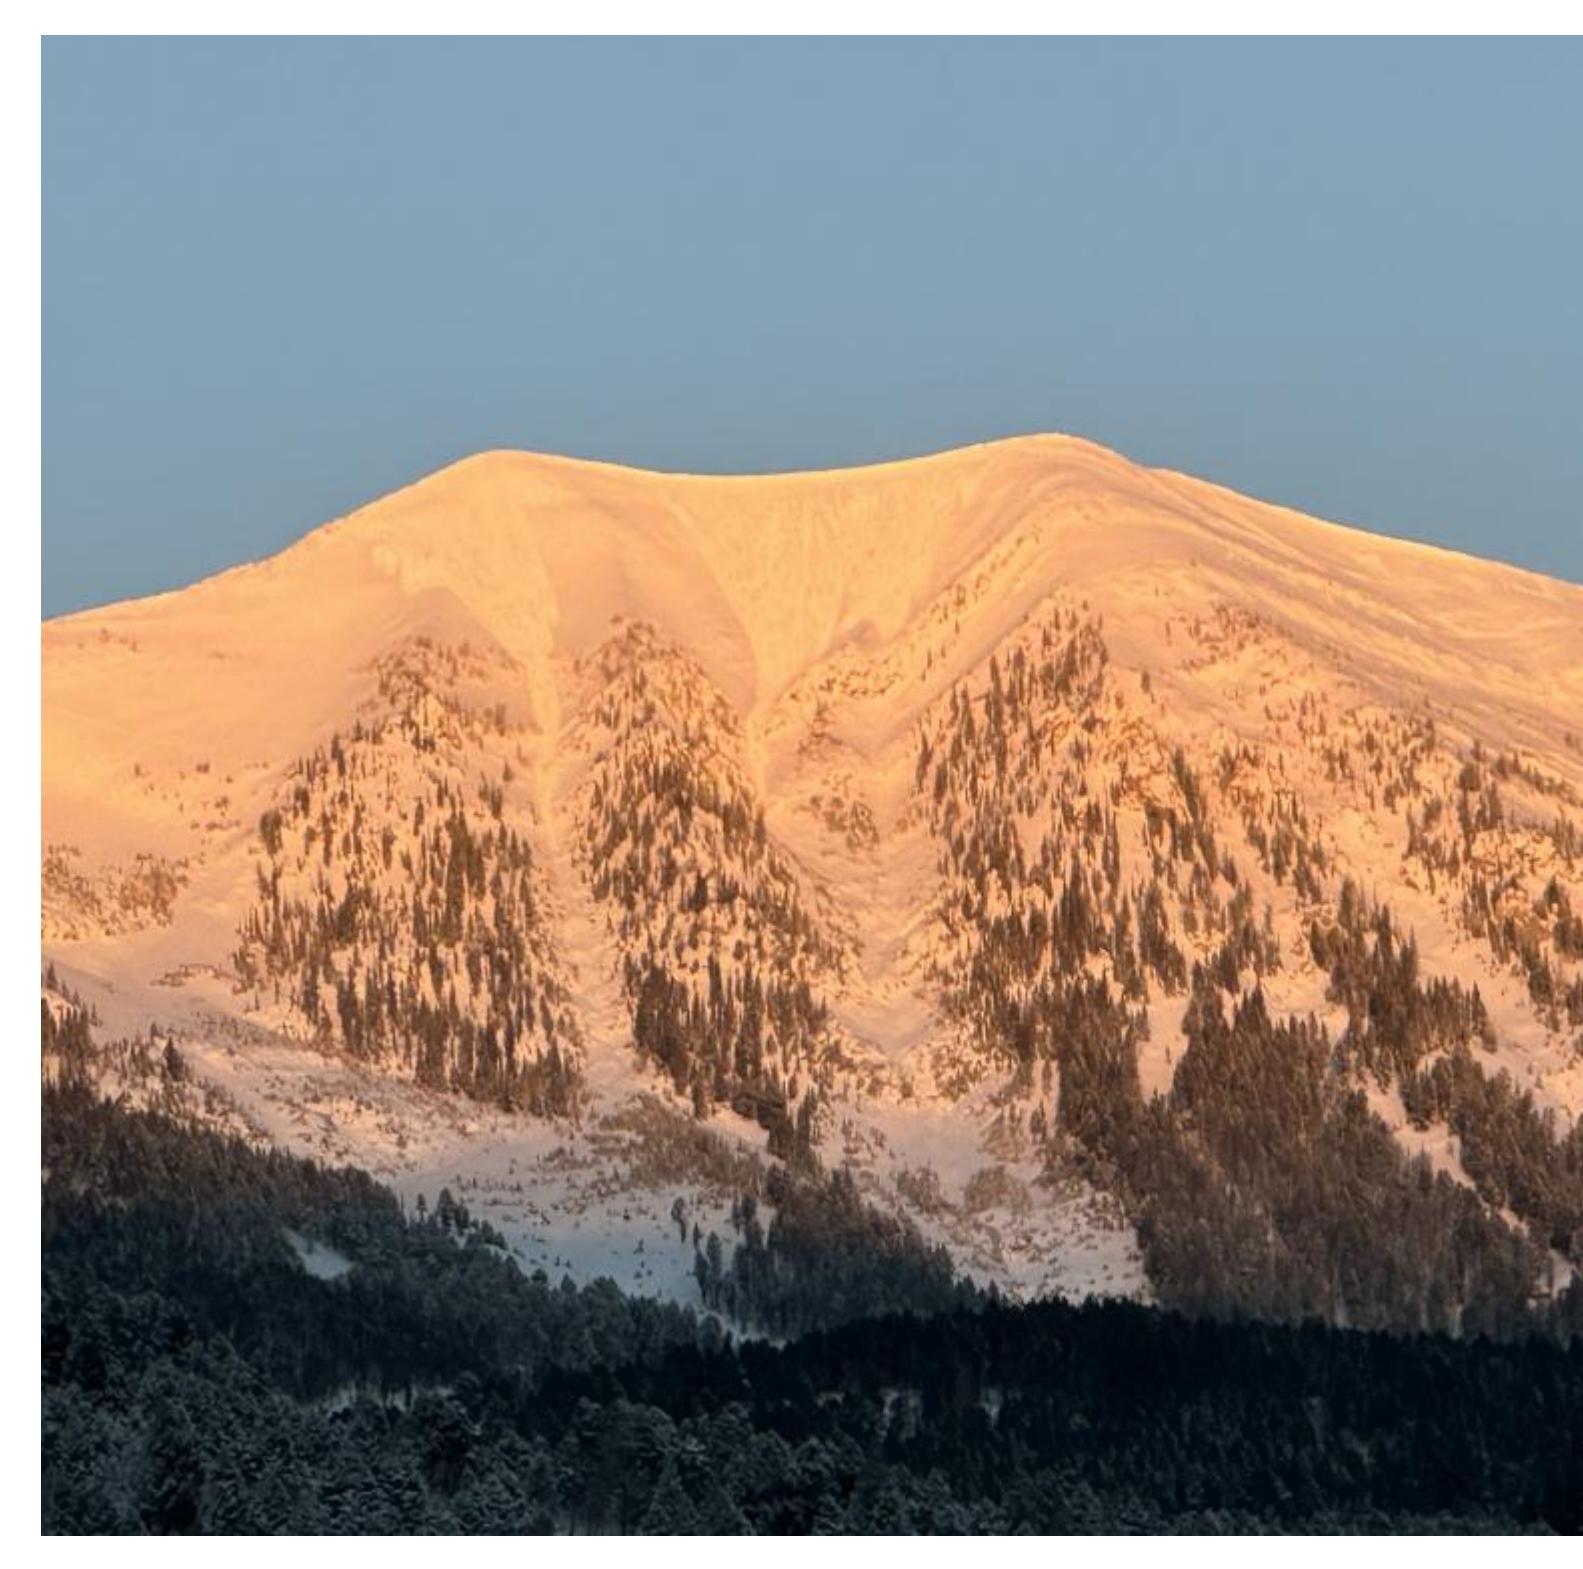
Driving up Bridger Canyon this morning, we noted several natural avalanches in wind loaded terrain on Saddle Peak, the Football Field, and in Mundy's Bowl. All The avalanches seems to be a similar wind slab problem. They broke just below the cornice line. Photo: GNFAC
